# Manhole Inspection Summary

Manhole # S53G\_\_017MH

Insp Date: **4/15/08 1:27 PM**

**Location** Address: **264 gough St**

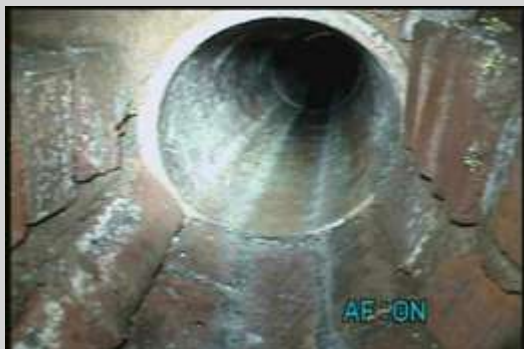
9 O'Clock Inflow

8 in. Circular Gravity Sewer  
Pipe In @ 9 O'Clock

Infiltration: **None** Pipe Seal Cond: **Unknown**
